Manhole Inspection Summary

Manhole # S13II_005MH

Location Address: **2831 NORTH AVE** Cross Street: **DUKELAND ST**

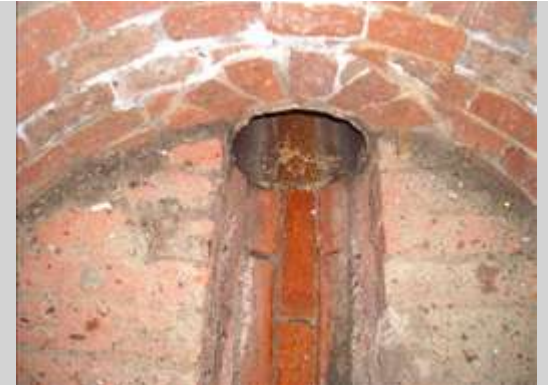
12 O'Clock Outflow

10 in. Circular Gravity Sewer
Pipe Out @ 12 O'Clock

Pipe Height: **9.6** (in.) Rod and Bar (Angled)
Pipe Material: **Clay** ☐ Pipe Lined
Invert Depth: **7.64** (ft.) Flow Characteristics: **Slow**
Deposits: ☒ None ☐ Mud ☐ Sludge ☐ Debris ☐ Grease
Silt Depth: **1** (in.) Deposits Extent: **Light**
Infiltration: **None** Pipe Seal Cond: **Sound**

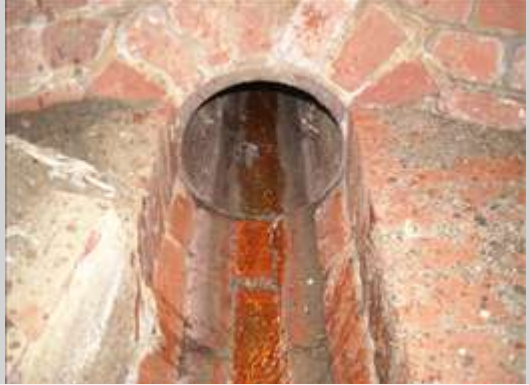
6 O'Clock Inflow

10 in. Circular Gravity Sewer
Pipe In @ 6 O'Clock

Pipe Height: **10.8** (in.) Rod and Bar (Angled)

Pipe Material: **Clay** ☐ Pipe Lined

Infiltration: **None** Pipe Seal Cond: **Sound**
